## Poultry Housing Tips

Using Polyurethane Foam Insulation to Totally Enclose Curtain-Sided Houses
Volume 17 Number 11 October, 2005

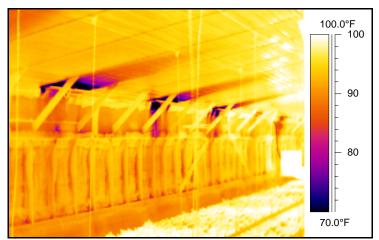
Figure 8. Air entering through inlets in a house where the curtain was sprayed with polyurethane insulation.

The reduction in air leakage significantly improved the performance of the house's inlet ventilation system. The lack of leakage can be seen in Figure 8 where the only fresh air entering the house when the fans come on is through the air inlets at the top of the ceiling.

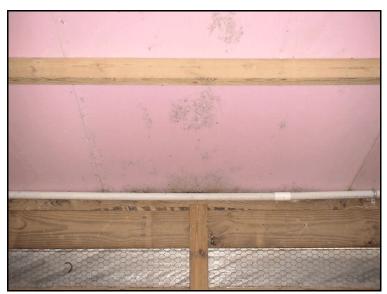
Figure 13. Beetle damage of polystyrene insulation. Dark spots are holes where beetles have burrowed into the insulation.

It is important to realize virtually any form of insulation installed in the side walls is prone to damage by darkling beetles (Figure 13). For instance, the thermal images in Figures 11 and 12 are of the ceiling and end wall in a house insulated with polystyrene board insulation during the summertime. The light spots are areas of increased heat gain due to burrowing of darkling beetles in the insulation. The greatest amount of damage is typically done at the cracks between pieces of board insulation where beetles have access to the softer inner part of the board insulation. The thermal images also show one of the potential weakness of polystyrene board insulation, that if not installed properly there can be significant leakage of air from outside the house from cracks between insulation boards (Figure 11).
